## Furca Perforation

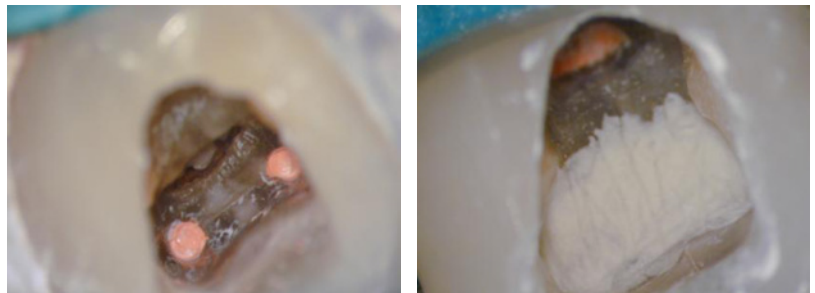
Canals are obturated and perforation site repaired with white MTA.
